Primex XR 72MHz Synchronized Time Solution

14000 Series Repeater Transmitter Troubleshooting Guide

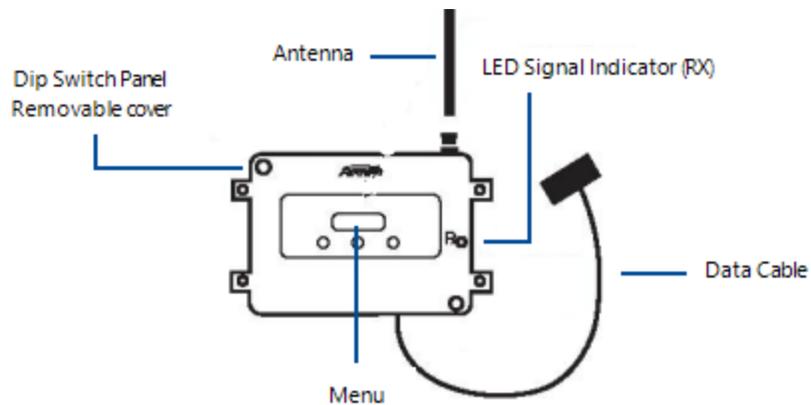
NOTE

A first generation Receiver Switch has a red channel selector knob with an arrow on its front flat side with an LED Signal Indicator (RX). Receiver Switch requires its own power supply at 9V. 250 mA output for power and is restricted to channels 1-16.

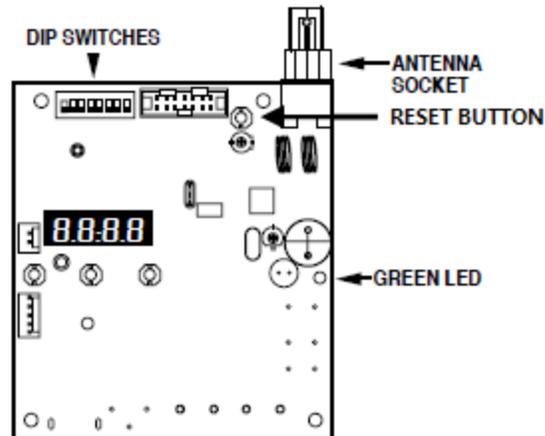
5. If the Receiver Switch still has a solid green LED Signal Indicator, it will need to be reset. To reset: remove its cover by removing the two Phillips head screws located on the cover's upper left and lower right side - be careful not to lose the Menu Up and Down buttons. From the upper right corner of the circuit board, push and release the reset button.

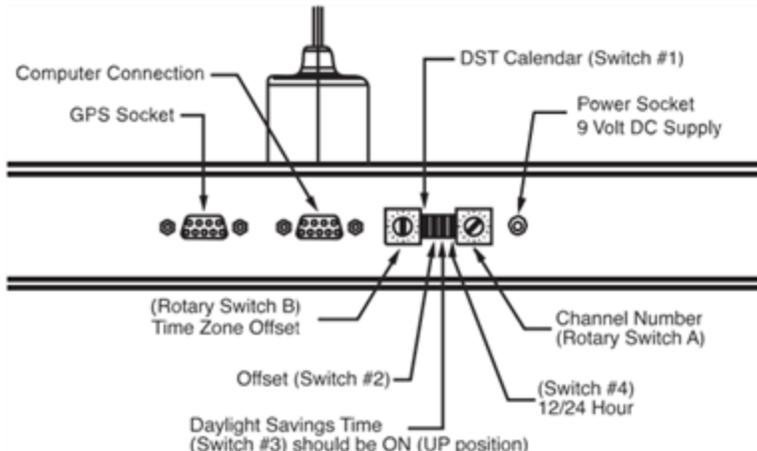
Do NOT adjust Rotary Switch A which is the Channel Switch. It's set to the frequency specified on the FCC/IC application

and is factory preset to the FM frequency on which the Transmitter will broadcast. A 14000 series Transmitter has 16 available channels.
