XR Time Synchronization

72MHz XR Series Repeater Transmitter Troubleshooting Guide

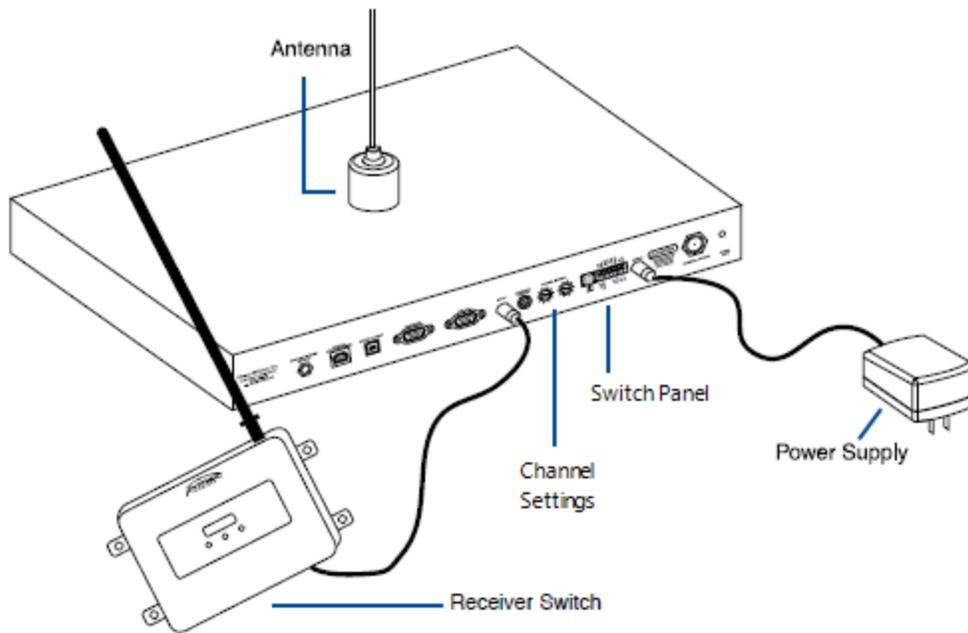
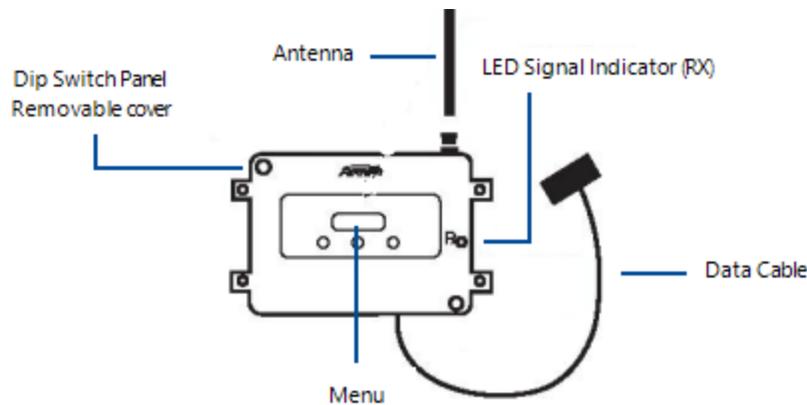
A XR Repeater (Satellite) Transmitter is an optional unit used with the XR Time Synchronization solution. The Transmitter is used to supplement and extend signal coverage and includes a Receiver Switch that receives a time signal from the Main Transmitter.

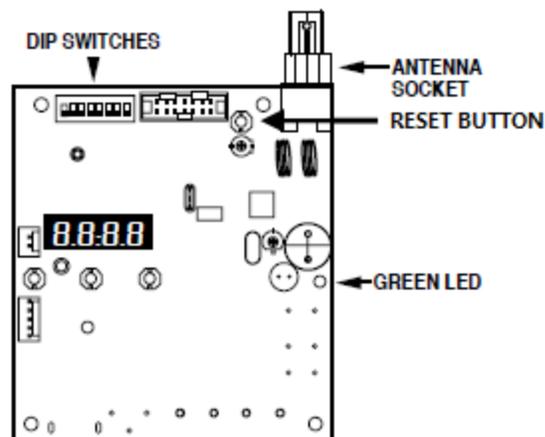
4. Return to the Repeater (Satellite) Transmitter. Verify the Receiver Switch has a flashing green LED Signal Indicator.
5. If the Receiver Switch still has a solid green LED Signal Indicator, it will need to be reset. To reset: remove its cover by removing the two Phillips head screws located on the cover's upper left and lower right side - be careful not to lose the Menu Up and Down buttons. From the upper right corner of the circuit board, push and release the reset button.

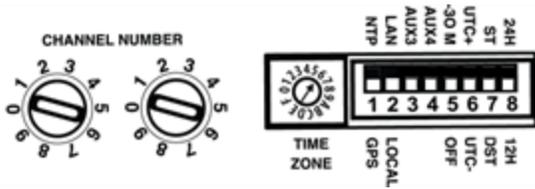
1. If the minutes and seconds are correct, but the hours are off or the day is off, then option switches #5, #6, or #7 may be in the wrong position.

Switch	Function	Up Position	Down Position
1	NTP/GPS	Receive time from NTP server.	Receive time from a GPS Receiver.
Transmitter switch settings must be set for NTP time, which is specific to the transmitter's firmware version. The firmware version is displayed on the transmitter front LCD display in the lower-left corner. For version 1.79, set switch 1 to the UP position and switch 2 to the DOWN position. For versions below 1.79, set switch 1 and 2 to the UP position.
